## **Chester Bowl Chalet**

Accessibility Review

Chester Bowl Chalet  
 Upper Level  
 City of Duluth, MN

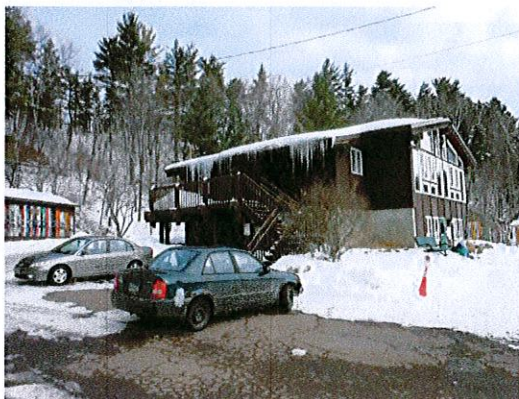
Chester Bowl Chalet is located at the base of the ski hill and ski jump at Chester Park. The 1970 building is 2 levels- the lower level includes offices, storage, ski patrol, race coordinator and multi-fixture toilet rooms; the upper level includes a warming/viewing area, concession counter and a private apartment. There is not currently an accessible route between levels. On-grade entries are provided to the lower level; there is not currently an accessible route to the upper level. The toilet rooms do not currently provide features of accessibility.

**Photo 1:** There is not currently an accessible route to the upper level.

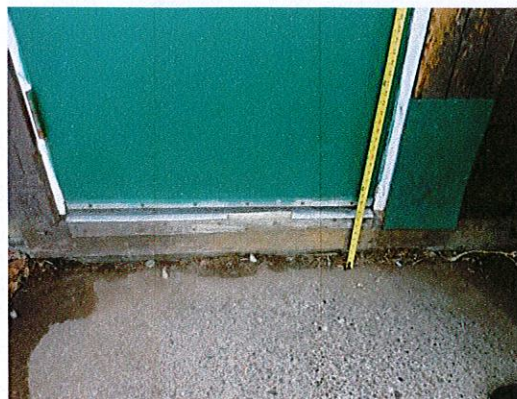
**Photo 2:** Patch the rise at the lower level entry.

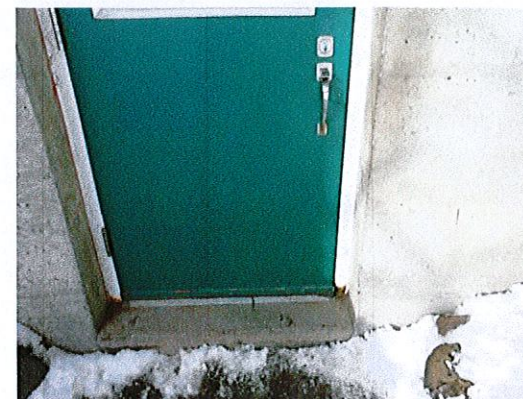
Location JQP # / Item #	Solution / Comments	Qty	Unit Cost	Total Cost	Priority	Estimated Compl. Date	Person Responsible	Actual Compl. Date	Actual Cost
<b>Chester Bowl- Upper Level</b>									
08A 16419	Provide an accessible route. IBC 1104 <i>There is not currently an accessible route to the upper level. Create an interior accessible route (elevator) or exterior accessible route. Photo 1.</i>	1	\$30,000	\$30,000	2				
<b>East (Toilet Room) Entry- Lower Level</b>									
08A 16411	Provide an accessible route. IBC 1104 <i>There is currently a 6 1/2" rise. Photo 3.</i>	1	\$3,000	\$3,000	2				
12B1 16412	Extend sidewalk to provide appropriate maneuvering clearance on the latch side of the door. ICC / ANSI 404.2.3.1	1	\$500	\$500	2				
12D 16410	Provide door hardware that does not require grasping, pinching or twisting to operate, such as lever. Exterior security hardware. ICC / ANSI 404.2.6 <i>Photo 3.</i>	1	\$325	\$325	2

**Photo 3:** Eliminate the step at the entry to the toilet rooms and replace the thumb-latch style door hardware.

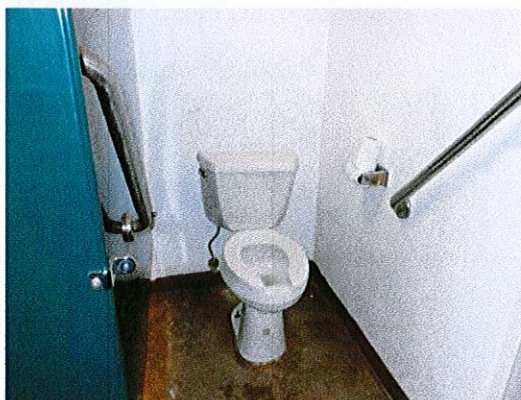
**Photo 4:** The toilet rooms provide an ambulatory accessible stall, but not a 5' accessible stall.

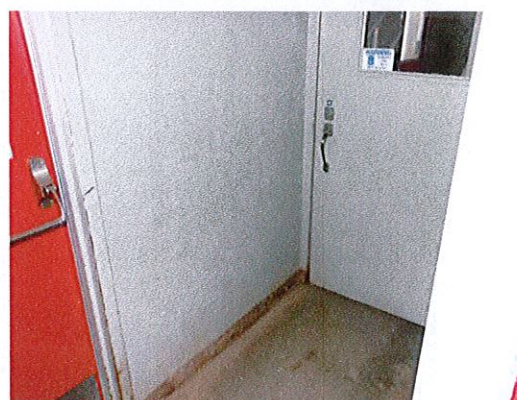
Location JQP # / Item #	Solution / Comments	Qty	Unit Cost	Total Cost	Priority	Estimated Compl. Date	Person Responsible	Actual Compl. Date	Actual Cost
<b>Concessions- Upper Level</b>									
20A 16418	Widen door opening to provide a minimum 32" clear opening. ICC / ANSI 404.2.2 <i>Currently provides a 29" clear opening.</i>	1	\$1,500	\$1,500	4				
27B 16416	Modify / replace sink and / or counter so rim is no higher than 34". ICC / ANSI 606.3 <i>Currently at 36".</i>	1	\$1,000	\$1,000	4				
				<i>Location Subtotal:</i>		\$2,500			
<b>Corridor/Vestibule (to toilet rooms)</b>									
20B 16413	Re-hinge / relocate door to provide needed maneuvering clearance on the latch pull side of the door. ICC / ANSI 404.2.3, Table 404.2.3.1 <i>Currently provides 3".</i>	1	\$400	\$400	4				
20I 16414	Relocate or remove one door to provide a larger vestibule. ICC / ANSI 404.2.5 <i>The corridor is currently 40" x 93" with doors on all 4 walls. Photo 5.</i>	1	\$1,500	\$1,500	4

**Photo 5:** View of vestibule at toilet room entry. The vestibule is too small to provide turning space or maneuvering clearance at any of the doors.

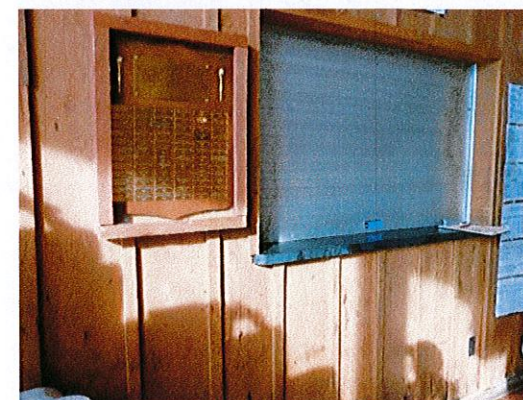
**Photo 6:** Lower the concession counter to 36" maximum (currently at 42 1/2").

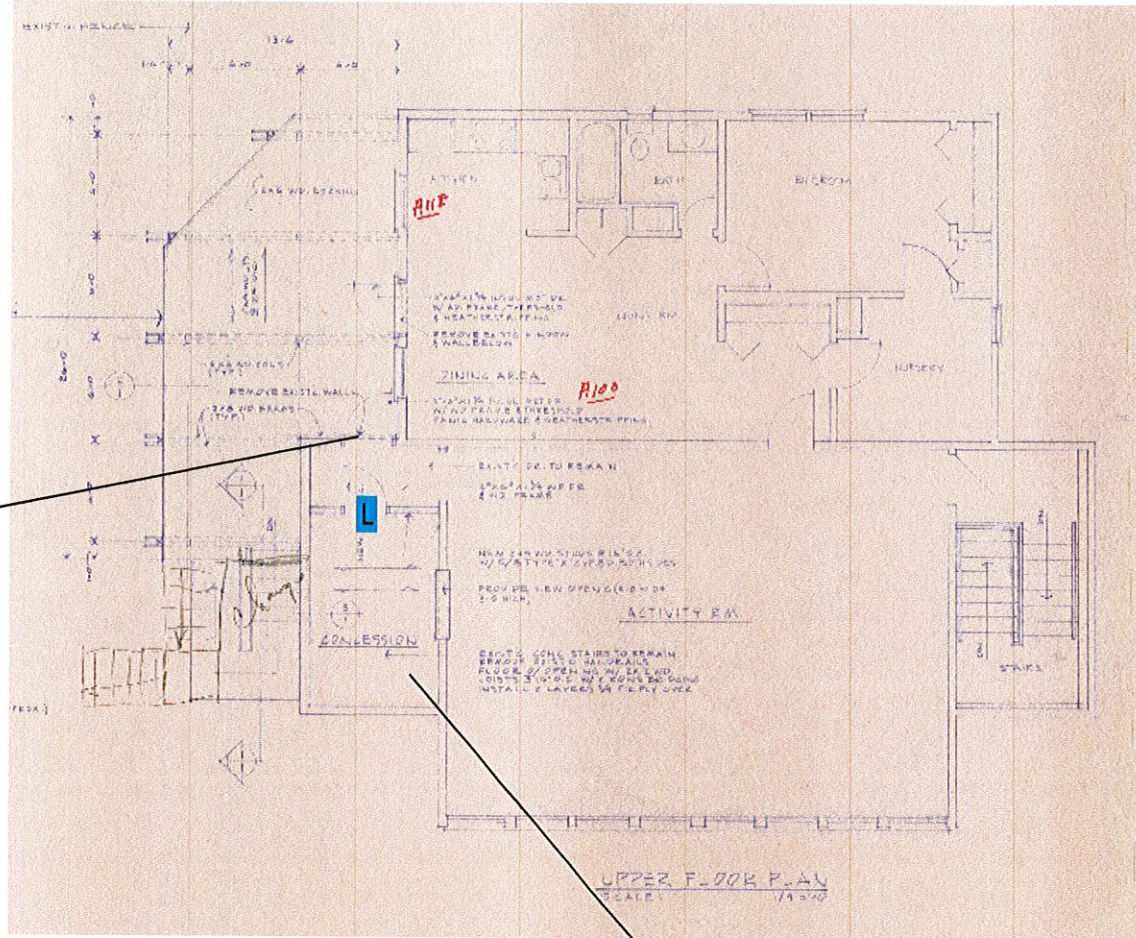
Add raised and braille signs

Create an accessible route

Lower the concession counter to 36" max.  
Replace the faucet hardware

L Install door lever hardware
