City Center West

Accessibility Review

Transition Plan - (location/priority)

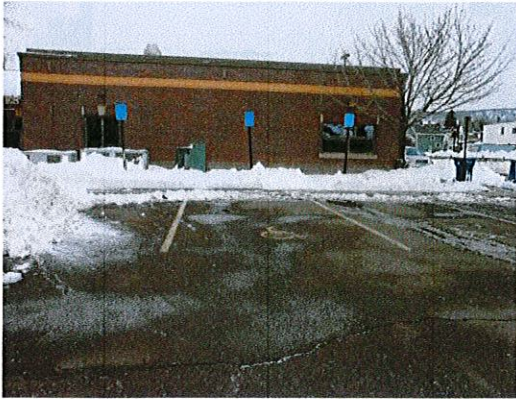
Photo 1: View of parking. Restripe the parking spaces to 8' wide with 8' wide aisle (can be shared between 2 spaces).

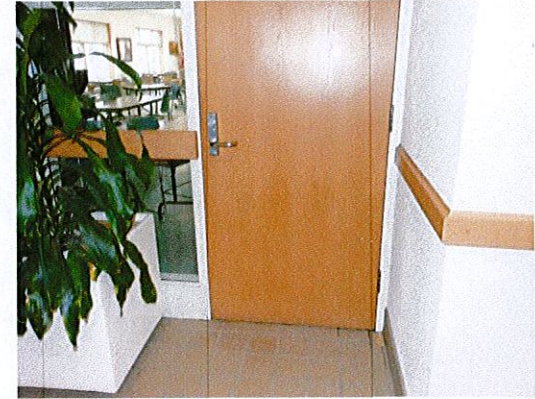
22H1	15532	Provide staple style pulls on both sides of the accessible stall door near the latch. ANSI 604.8.3		1	\$50	\$50	3		
22Q	15534	Insulate or otherwise protect exposed pipes at lavatory. ICC / ANSI 606.6		1	\$50	\$50	3		
22Z	15533	Provide a coat hook positioned so the highest operable part is no higher than 48". ICC / ANSI 604.11		1	\$50	\$50	3		
<i>Location Subtotal:</i>						\$1,940			
Small Meeting Room / 103									
20B1	15551	Relocate object to achieve needed maneuvering clearance on the pull side of the door. ICC / ANSI 404.2.3, Table 404.2.3.1 <i>The plants currently obstruct the entry from the corridor. Photo 3.</i>		1	\$50	\$50	3

Photo 3: Relocate the planter that currently obstructs the pull side clearance to the small meeting room (103).

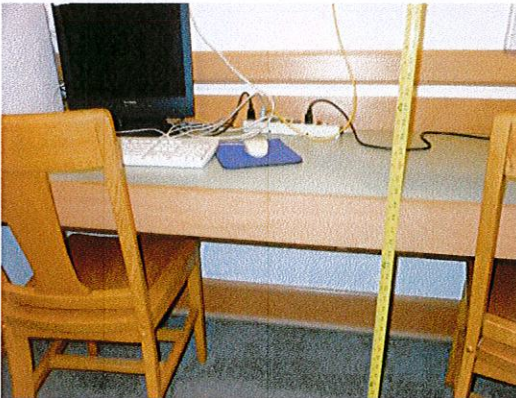
29A 15526	Provide a minimum of one computer lab on an accessible permanent or movable table / counter. The top height of the surface is to be 28"-34" above the floor, with knee clearance a minimum 27" high by 30" wide x 19" deep. ICC / ANSI 902.2 <i>Relocate the reference computer to a location that provides 27" minimum knee clearance; currently provides 25". Photo 4.</i>	1	\$200	\$200	3				
-----------	--	---	-------	-------	---	--	--	--	--

Photo 4: Relocate (or add) a reference computer at a location with 27" minimum knee clearance. (Currently provides 25".)

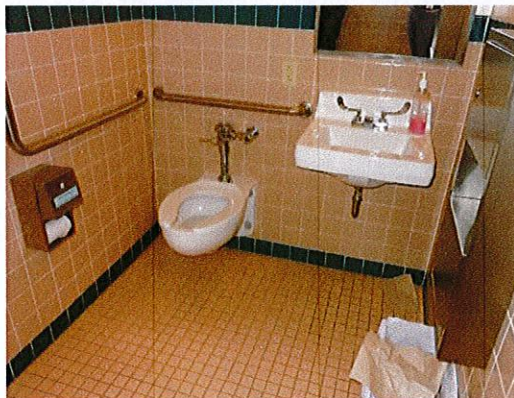
Location JQP # / Item #	Solution / Comments	Qty	Unit Cost	Total Cost	Priority	Estimated Compl. Date	Person Responsible	Actual Compl. Date	Actual Cost
Library									
21A1 15519	Lower a minimum 36" wide section of counter to a maximum height of 36" above the floor. ICC ANSI 904.3 <i>Currently at 36 1/2".</i>	1	\$1,000	\$1,000	4				
Library Entry									
20M 15518	Provide a smooth surface at the bottom (within 10" of the floor) of the door, that extends the full width of the door. ICC / ANSI 404.2.9 <i>Currently provides 8".</i>	2	\$50	\$100	4				
Library- Single User Toilet Room									
22C2 (MN) 15521	Relocate the lavatory or enlarge the room to provide a minimum 42" between the lavatory and the center of the water closet. ANSI 604.3.2 <i>The sink is currently within the clearance for the toilet. No action recommended, okay at time of construction.</i>	1	\$0	\$0	4				
22N1 15522	Relocate the water closet flush valve so it is located on the open side of the water closet or provide an automatic flush system. MN1341 604.6 <i>Photo 5.</i>	1	\$400	\$400	4

Photo 5: View of single user toilet room in library.

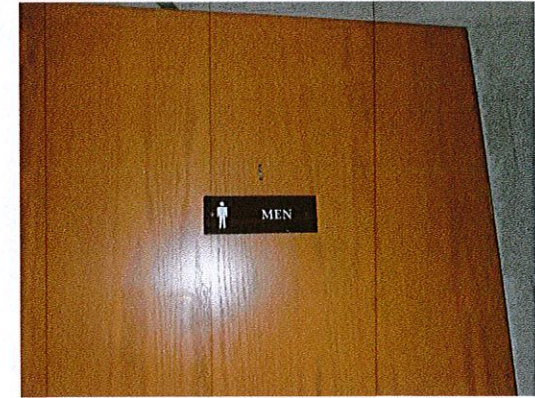
Photo 6: Add signs with raised and braille characters to the toilet rooms.

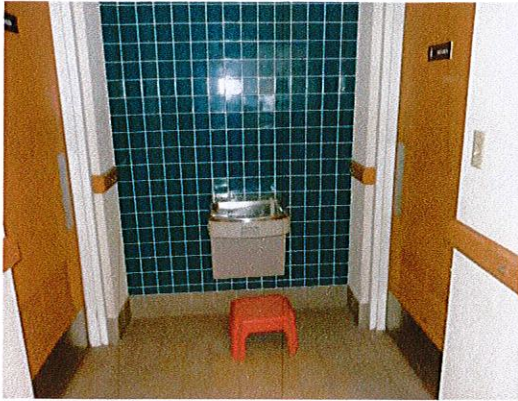
<i>Location Subtotal:</i>					\$5,000
Drinking Fountain									
22-20B1 15539	Remove / relocate / replace moveable object to provide needed maneuvering clearance on the pull side of the door. ICC / ANSI 404.2.3, Table 404.2.3.1 <i>The drinking fountain currently obstructs the push side clearance into the men's and women's toilet rooms. Photo 7.</i>	1	\$50	\$50	4				
Grand Avenue Entry									
20M 15550	Provide a smooth surface at the bottom (within 10" of the floor) of the door, that extends the full width of the door. ICC / ANSI 404.2.9 <i>Currently provides 8".</i>	2	\$50	\$100	4

Photo 7: The drinking fountain currently obstructs the push side clearance into the men's and women's toilet rooms.

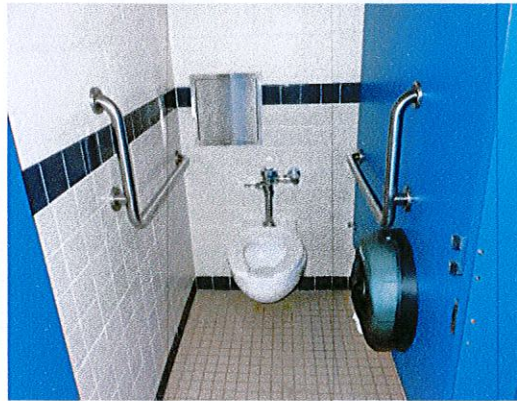
Photo 8: View of toilet room. Typical toilet rooms provide an ambulatory accessible stall, but not a stall with 60" clearance.
