## **Park Point Beach House**

Accessibility Review

City of Duluth, MN

2013

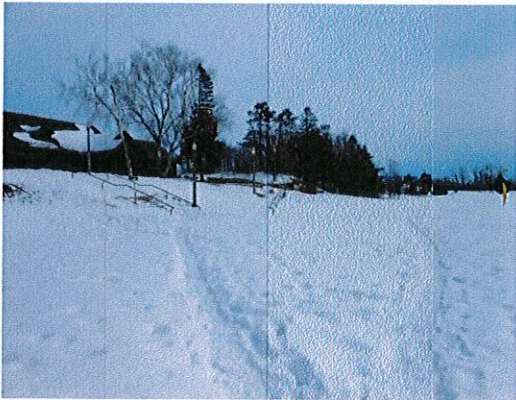
**Photo 1:** An accessible route is provided to the main entry adjacent to the stairs. *This is a good example of accessibility.*

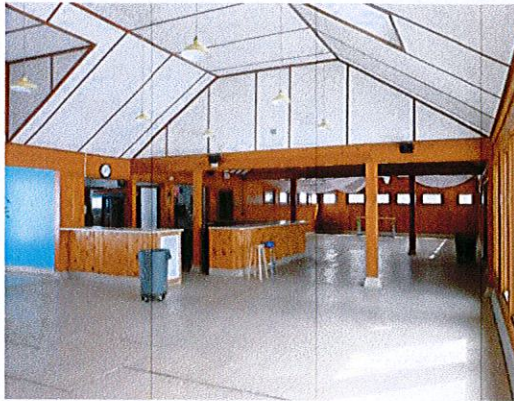
**Photo 2:** Lower the concession counter to 36" maximum (currently at 43").

Location	Solution / Comments	Qty	Unit Cost	Total Cost	Priority	Estimated Compl. Date	Person Responsible	Actual Compl. Date	Actual Cost
<b>Concessions</b>									
21A1	16457 Lower a minimum 36" wide section of counter to a maximum height of 36" above the floor. ICC ANSI 904.3 <i>Currently at 43". Photo 2.</i>	1	\$1,000	\$1,000	3				
<b>Deck Doors</b>									
20A	16456 Widen door opening to provide a minimum 32" clear opening. ICC / ANSI 404.2.2 <i>The doors from the main room to the deck and lake currently provide a 31" clear opening.</i>	2	\$1,500	\$3,000	3				
<b>Lifeguard Office</b>									
20A	16455 Widen door opening to provide a minimum 32" clear opening. ICC / ANSI 404.2.2 <i>Currently provides 25" clear opening.</i>	1	\$1,500	\$1,500	3				
				<b>Priority # 3 Total</b>	<b>\$5,500</b>

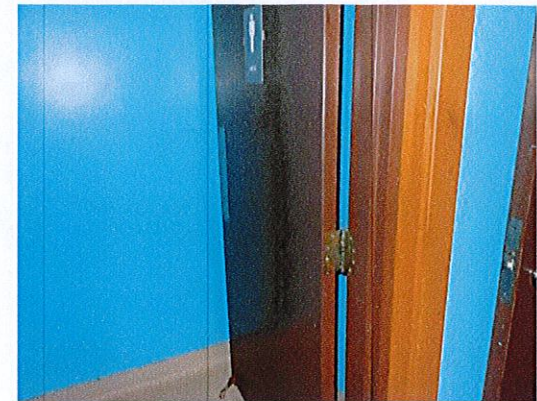
**Photo 3:** Maneuvering clearance is not currently provided at the toilet room entry doors.

Location	Solution / Comments	Qty	Unit Cost	Total Cost	Priority	Estimated Compl. Date	Person Responsible	Actual Compl. Date	Actual Cost
JQP # / Item #									
<b>Men's Toilet Room</b>									
22-20B	16448	Re-hinge / relocate door to provide needed maneuvering clearance on the latch pull side of the door. ICC / ANSI 404.2.3, Table 404.2.3.1 <i>The door is currently propped in the 'open' position. Photo 3.</i>	1	\$750	\$750	2			
22B	16447	Install signage with appropriate raised and Braille lettering. MN 1341 1110.2	1	\$40	\$40	2			
22E1	16453	Enlarge to provide a fully compliant 60" minimum wide toilet stall. (Currently an alternate stall is provided). MN 1341 604.3.1 <i>Photo 5.</i>	1	\$1,350	\$1,350	2			
22H1	16450	Provide staple style pulls on both sides of the accessible stall door near the latch. ANSI 604.8.3	1	\$50	\$50	2			
22K6 (MN)	16454	Remove the existing grab bar configuration and replace with a compliant grab bar configuration. MN 1341 604.5.1 ANSI 604.5.2 <i>Photo 5.</i>	1	\$400	\$400	2

Location JQP # / Item #	Solution / Comments	Qty	Unit Cost	Total Cost	Priority	Estimated Compl. Date	Person Responsible	Actual Compl. Date	Actual Cost
<b>Women's Toilet Room</b>									
22-20B 16459	Re-hinge / relocate door to provide needed maneuvering clearance on the latch pull side of the door. ICC / ANSI 404.2.3, Table 404.2.3.1 <i>The door is currently propped in the 'open' position. Photo 3.</i>	1	\$750	\$750	2				
22B 16458	Install signage with appropriate raised and Braille lettering. MN 1341 1110.2	1	\$40	\$40	2				
22E1 16464	Enlarge to provide a fully compliant 60" minimum wide toilet stall. (Currently an alternate stall is provided). MN 1341 604.3.1 <i>Photo 5.</i>	1	\$1,350	\$1,350	2				
22H1 16461	Provide staple style pulls on both sides of the accessible stall door near the latch. ANSI 604.8.3	1	\$50	\$50	2				
22K6 (MN) 16465	Remove the existing grab bar configuration and replace with a compliant grab bar configuration. MN 1341 604.5.1 ANSI 604.5.2 <i>Photo 5.</i>	1	\$400	\$400	2

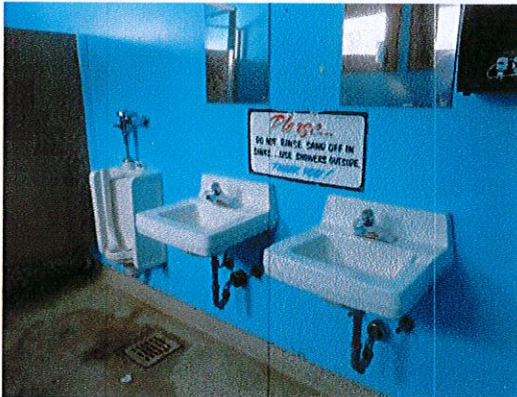
**Photo 4:** Insulate the pipes at the sink.

22Q	16449	Insulate or otherwise protect exposed pipes at lavatory. ICC / ANSI 606.6 <i>Photo 4.</i>	1	\$50	\$50	2			
22T	16452	Lower the towel dispenser/dryer so the highest operable part is no higher than 48" (44" maximum if located above lavatory or counter). ANSI 308	1	\$50	\$50	2			
22V	16451	Install a full-height mirror or provide a mirror where the bottom of the reflective surface is no higher than 40" above the floor. MN 1341 603.3	1	\$300	\$300	2			
				<i>Location Subtotal:</i>					\$2,990

22Q 16460	Insulate or otherwise protect exposed pipes at lavatory. ICC / ANSI 606.6 <i>Photo 4.</i>	1	\$50	\$50	2				
22T 16463	Lower the towel dispenser/dryer so the highest operable part is no higher than 48" (44" maximum if located above lavatory or counter). ANSI 308	1	\$50	\$50	2				
22V 16462	Install a full-height mirror or provide a mirror where the bottom of the reflective surface is no higher than 40" above the floor. MN 1341 603.3	1	\$300	\$300	2				
				<i>Location Subtotal:</i>					\$2,990
									<b>Priority # 2 Total \$5,980</b>

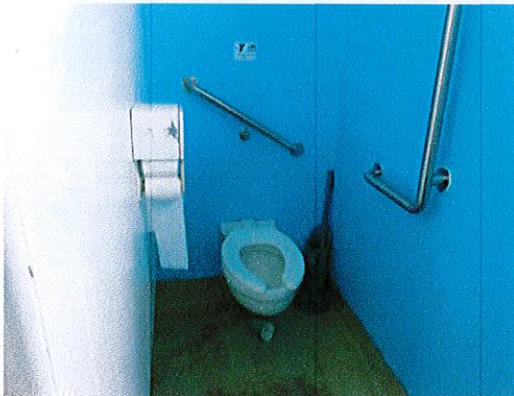
**Photo 5:** The toilet rooms are not currently accessible (grab bars have been installed but they are not the correct configuration and the stall is too narrow).
