Traffic Maintenance- Lund Toolhouse

Accessibility Review

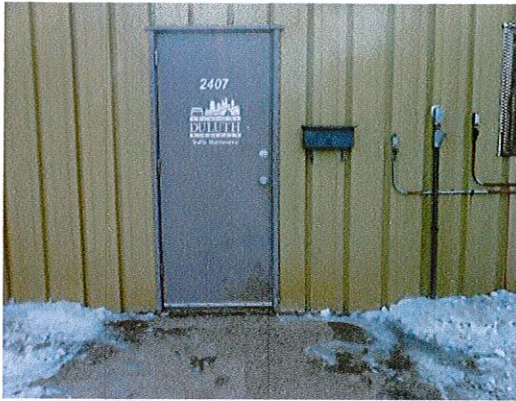
Photo 1: View of main entry. Replace the knob with a style that does not require grasping, pinching or twisting to operate (such as a lever).

Location	Solution / Comments	Qty	Unit Cost	Total Cost	Priority	Estimated Compl. Date	Person Responsible	Actual Compl. Date	Actual Cost
JQP # / Item #									
Main Entry									
12D 15936	Provide door hardware that does not require grasping, pinching or twisting to operate, such as lever. Exterior security hardware. ICC / ANSI 404.2.6 <i>Photo 1.</i>	1	\$325	\$325	1				
				Priority # 1 Total	\$325

Location	Solution / Comments	Qty	Unit Cost	Total Cost	Priority	Estimated Compl. Date	Person Responsible	Actual Compl. Date	Actual Cost
JQP # / Item #									
Main Entry									
12H 15937	Bevel / replace / reset threshold so there is no abrupt rise greater than 1/2" or slope greater than 1:2. ICC / ANSI 404.2.4 <i>Photo 1.</i>	1	\$200	\$200	2				
				Priority # 2 Total	\$200

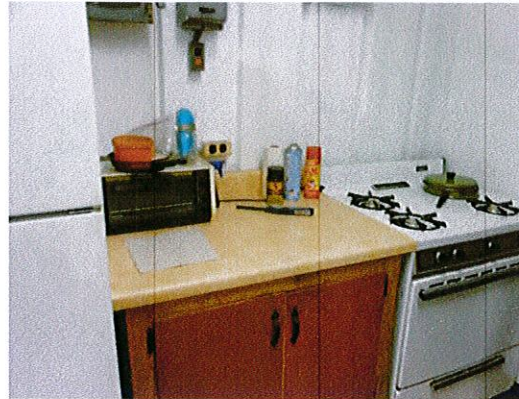
Photo 2: View of break room. The kitchen does not currently provide any features of accessibility.

Location JQP # / Item #	Solution / Comments	Qty	Unit Cost	Total Cost	Priority	Estimated Compl. Date	Person Responsible	Actual Compl. Date	Actual Cost
Break Room									
25J9 15939	Create an accessible kitchen, including: roll under work surface, roll under sink, range with front or side controls, and compliant clearances. ANSI 804 <i>Photo 2.</i>	1	\$7,000	\$7,000	4				
Drinking Fountain									
41A1 15942	Provide a minimum of one drinking fountain that has a 36" spout height accessible for persons using wheelchairs (low) and one standard height (high) drinking fountain with a spout height 38" minimum and 43" maximum for persons who have difficulty bending or stooping. ANSI 602.4 <i>There is currently 1 drinking fountain with a spout at 46".</i>	1	\$1,500	\$1,500	4				
Offices									
20D 15938	Provide door hardware that does not require grasping, pinching or twisting to operate, such as lever. ICC / ANSI 404.2.6	4	\$250	\$1,000	4

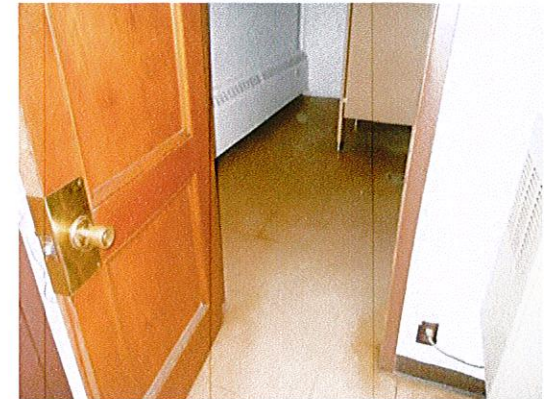
Photo 3: The entry door to the toilet room currently provides a 26 1/2" clear opening.

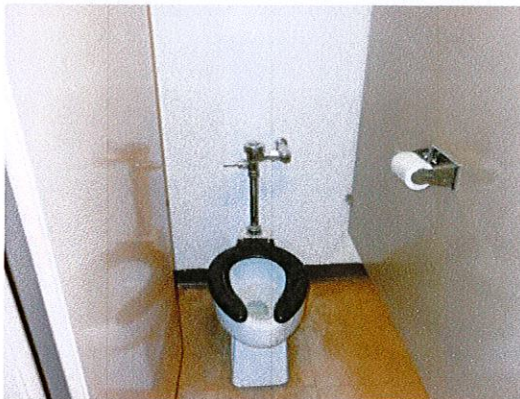
Photo 4: The toilet room does not currently provide any features of accessibility.

Location JQP # / Item #	Solution / Comments	Qty	Unit Cost	Total Cost	Priority	Estimated Compl. Date	Person Responsible	Actual Compl. Date	Actual Cost
Break Room- Sink									
22Q 15940	Insulate or otherwise protect exposed pipes at lavatory. ICC / ANSI 606.6	1	\$50	\$50	3				
27D 15941	Replace faucet hardware. ICC / ANSI 309.4, 606.4	1	\$450	\$450	3				
				<i>Location Subtotal:</i>					\$500
Men's Toilet Room									
22-20A 15947	Widen door opening to provide a minimum 32" clear opening. ICC / ANSI 404.2.2 <i>Currently provides a 26 1/2" clear opening. Photo 3.</i>	1	\$1,500	\$1,500	3				
22-20D 15948	Provide door hardware that does not require grasping, pinching or twisting to operate, such as lever, push pull, etc. ICC / ANSI 404.2.6	1	\$250	\$250	3				
22D 15949	Remove interior partitions to create a single use toilet room. It is recommended that a privacy lock be installed. ICC / ANSI 603.2 <i>Photo 4.</i>	1	\$1,500	\$1,500	3

22Q 15943	Insulate or otherwise protect exposed pipes at lavatory. ICC / ANSI 606.6	1	\$50	\$50	3				
22R 15944	Replace the existing lavatory faucet with hardware that does not require grasping, pinching or twisting to operate. ICC / ANSI 309.4, 606.4	1	\$450	\$450	3				
22T 15946	Lower the towel dispenser/dryer so the highest operable part is no higher than 48" (44" maximum if located above lavatory or counter). ANSI 308 <i>Currently at 67".</i>	1	\$50	\$50	3				
22V 15945	Install a full-height mirror or provide a mirror where the bottom of the reflective surface is no higher than 40" above the floor. MN 1341 603.3 <i>Currently at 54".</i>	1	\$300	\$300	3				
				<i>Location Subtotal:</i>					\$4,100
									Priority # 3 Total \$4,600
