## **Merritt Community Club**

Accessibility Review

Transition Plan - (location/priority)

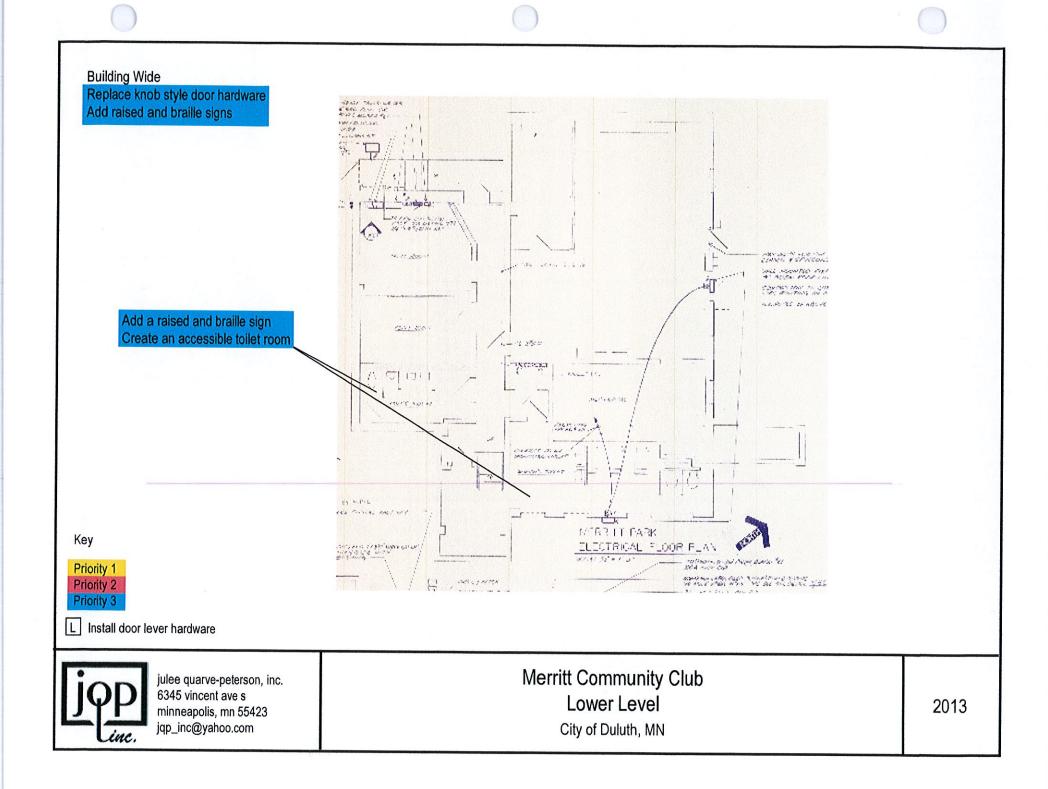
22.1	16100	Upgrade toilet room to be fully accessible. IBC 1109.2	1	\$10,000	\$10,000	3				
		There are currently 2 toilets and 3 showers. No features of accessibility are provided. Phot 6.	o							
228	16098	Install signage with appropriate raised and Braille lettering. MN 1341 1110.2	1	\$40	\$40	3				
			Location Su	btotal:	\$10,040					
			Priority #	f 3 Total	\$26,730	)

<u>Photo 6:</u> View of women's toilet room. There are currently no features of accessibility provided.
