Fire Station 2

Accessibility Review

Transition Plan - (location/priority)

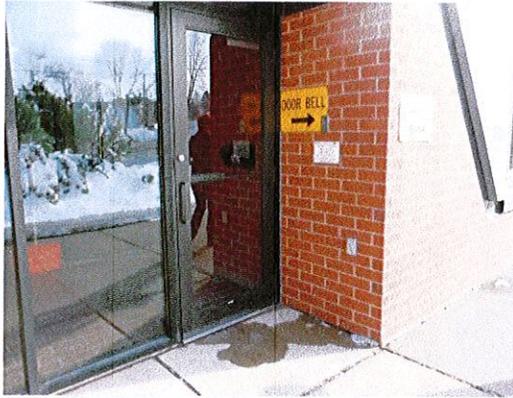
Photo 1: A doorbell is provided for visitors to enter the fire hall. Lower the doorbell to 48" maximum (currently at 58").

Location JQP # / Item #	Solution / Comments	Qty	Unit Cost	Total Cost	Priority	Estimated Compl. Date	Person Responsible	Actual Compl. Date	Actual Cost
Main Entry- Door Bell									
47B 15856	Replace and/or reposition the two-way communication system's control mechanism to be mounted no higher than 48" above the floor. ICC/ANSI 308.2, 308.3 <i>Currently at 58". Photo 1.</i>	1	\$150	\$150	2				
Parking									
05A 15872	Stripe an appropriate number of accessible parking stalls and provide appropriate permanent signage. IBC 1106.1 <i>There are approximately 12 parking spaces on site (10 on the Superior St. side, 2 in front). Currently no parking spaces have been designated as accessible.</i>	1	\$400	\$400	2				
				Priority # 2 Total	\$550

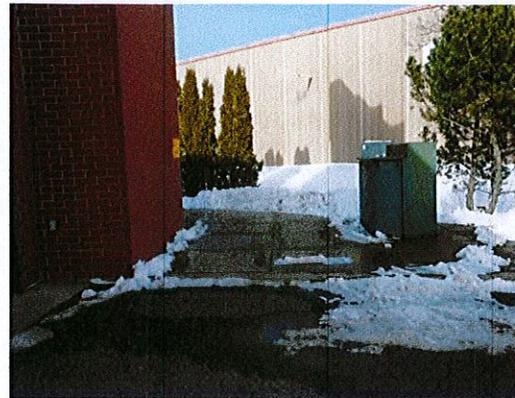
Photo 2: Add a curb cut to create an accessible route to the service door on the Superior Street side.

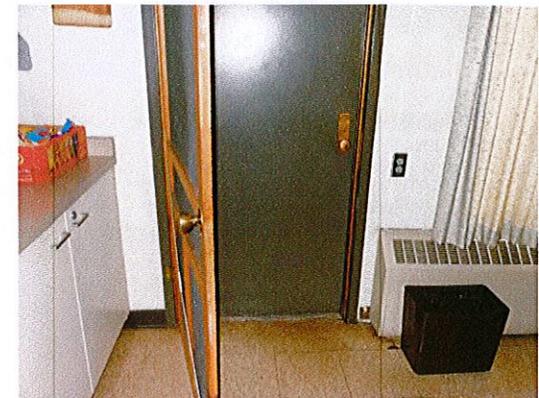
Photo 3: To patio. Replace the knob with a style that does not require grasping, pinching or twisting to operate (such as a lever).

Location JQP # / Item #	Solution / Comments	Qty	Unit Cost	Total Cost	Priority	Estimated Compl. Date	Person Responsible	Actual Compl. Date	Actual Cost
Patio Door									
12D 15858	Provide door hardware that does not require grasping, pinching or twisting to operate, such as lever. Exterior security hardware. ICC / ANSI 404.2.6 Photo 3.	2	\$325	\$650	3				
Service Door (Superior St. Side)									
07A 15871	Add a curb cut / ramp where the accessible route crosses a curb. ICC / ANSI 303, 402.2 Photo 2.	1	\$1,000	\$1,000	3				
12D 15875	Provide door hardware that does not require grasping, pinching or twisting to operate, such as lever. Exterior security hardware. ICC / ANSI 404.2.6	1	\$325	\$325	3				
47B 15870	Replace and/or reposition the two-way communication system's control mechanism to be mounted no higher than 48" above the floor. ICC/ANSI 308.2, 308.3 Currently at 58".	1	\$150	\$150	3

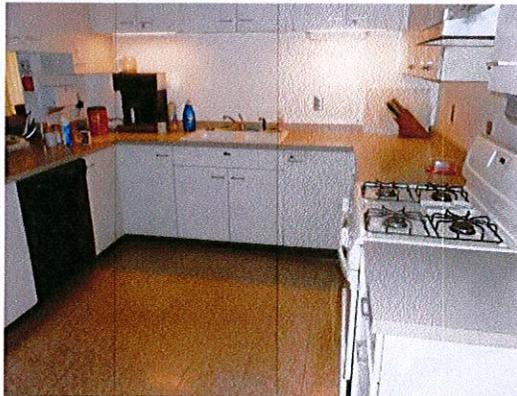
Photo 4: View of kitchen. There are currently no features of accessibility provided.

Kitchen									
25J9 15857	Create an accessible kitchen, including: roll under work surface, roll under sink, range with front or side controls, and compliant clearances. ANSI 804 <i>Photo 4.</i>	1	\$7,000	\$7,000	4				
Main Entry									
20M 15855	Provide a smooth surface at the bottom (within 10" of the floor) of the door, that extends the full width of the door. ICC / ANSI 404.2.9 <i>Currently 7".</i>	1	\$50	\$50	4

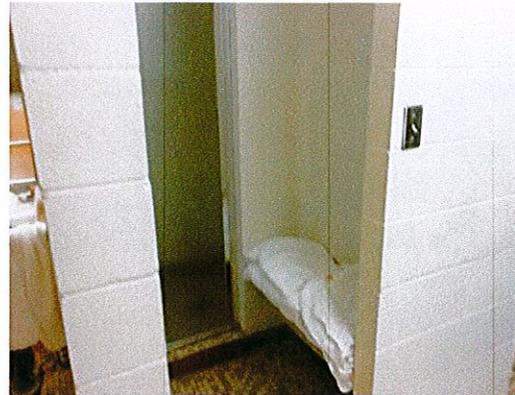
Photo 5: View of locker room. Currently no features of accessibility are provided.

Location JQP # / Item #	Solution / Comments	Qty	Unit Cost	Total Cost	Priority	Estimated Compl. Date	Person Responsible	Actual Compl. Date	Actual Cost
Men's Locker Room									
22-20B1 15865	Remove / relocate / replace moveable object to provide needed maneuvering clearance on the pull side of the door. ICC / ANSI 404.2.3, Table 404.2.3.1 <i>The lockers obstruct the maneuvering clearance on the pull side of the door.</i>	1	\$50	\$50	4				
24 15864	Provide a fully compliant unisex toilet/shower room. IBC 1109.2 <i>The locker room provides 2 toilets, 2 urinals, 2 sinks and 2 shower stalls. Currently no features of accessibility have been provided. Photo 5.</i>	1	\$20,000	\$20,000	4				
				<i>Location Subtotal:</i>					\$20,050
Private (Captain's) Sleeping Room- Bathroom									
24 15859	Provide a fully compliant unisex toilet/shower room. IBC 1109.2	1	\$20,000	\$20,000	4				
Sleeping / Weight Room (to garage)
