Fire Station 7

Accessibility Review

Transition Plan - (location/priority)

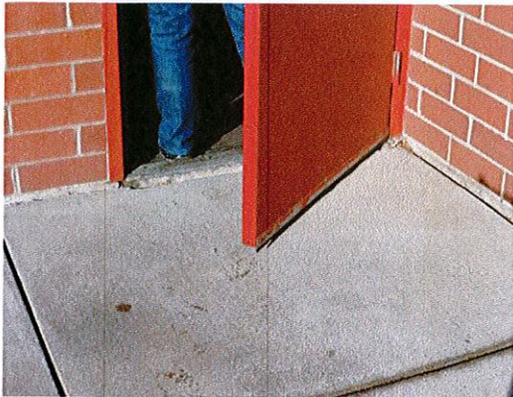
| Location JQP # / Item # | Solution / Comments | Qty | Unit Cost | Total Cost | Priority | Estimated Compl. Date | Person Responsible | Actual Compl. Date | Actual Cost |
|---|---|---|---|---|---|---|---|---|---|
| 12H 15681 | Bevel / replace / reset threshold so there is no abrupt rise greater than 1/2" or slope greater than 1:2. ICC / ANSI 404.2.4 <i>Currently 1" rise. Photo 1.</i> | 1 | \$200 | \$200 | 2 | | | | |

Photo 1: Modify to eliminate the 1" rise at the main entry.

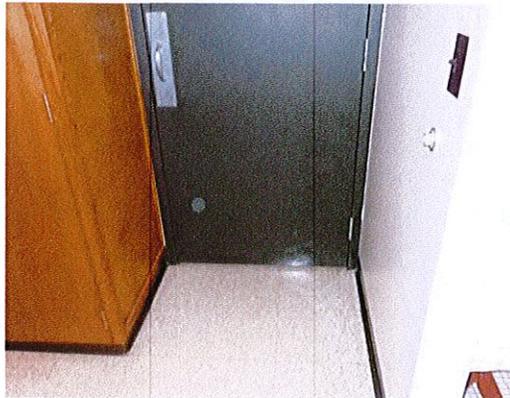
| Location JQP # / Item # | Solution / Comments | Qty | Unit Cost | Total Cost | Priority | Estimated Compl. Date | Person Responsible | Actual Compl. Date | Actual Cost |
|---|---|---|---|---|---|---|---|---|---|
| 20B1 15697 | Relocate object to achieve needed maneuvering clearance on the pull side of the door. ICC / ANSI 404.2.3, Table 404.2.3.1 <i>The lockers currently obstruct maneuvering clearance at the door. Photo 2.</i> | 1 | \$50 | \$50 | 4 | | | | |

Photo 2: The lockers currently obstruct the maneuvering clearance.

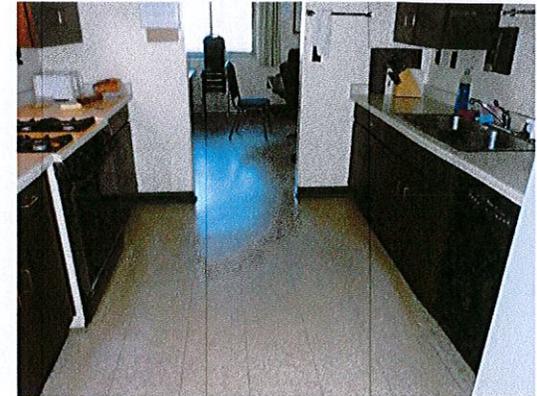
| Location JQP # / Item # | Solution / Comments | Qty | Unit Cost | Total Cost | Priority | Estimated Compl. Date | Person Responsible | Actual Compl. Date | Actual Cost |
|---|---|---|---|---|---|---|---|---|---|
| 25J9 15698 | Create an accessible kitchen, including: roll under work surface, roll under sink, range with front or side controls, and compliant clearances. ANSI 804 Photo 3. | 1 | \$7,000 | \$7,000 | 4 | | | | |

Photo 3: View of kitchen. There are currently no features of accessibility provided.

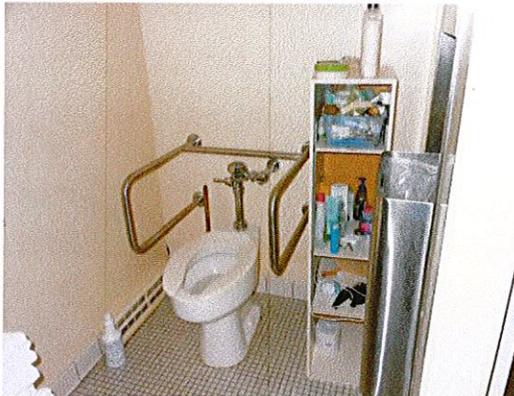
| Location JQP # / Item # | Solution / Comments | Qty | Unit Cost | Total Cost | Priority | Estimated Compl. Date | Person Responsible | Actual Compl. Date | Actual Cost |
|---|---|---|---|---|---|---|---|---|---|
| 22K6 (MN) 15688 | Remove the existing grab bar configuration and replace with a compliant grab bar configuration. MN 1341 604.5.1 ANSI 604.5.2 <i>Photo 4.</i> | 1 | \$400 | \$400 | 3 | | | | |

Photo 4: View of women's locker room. Replace the existing grab bar contraption with compliant grab bars.

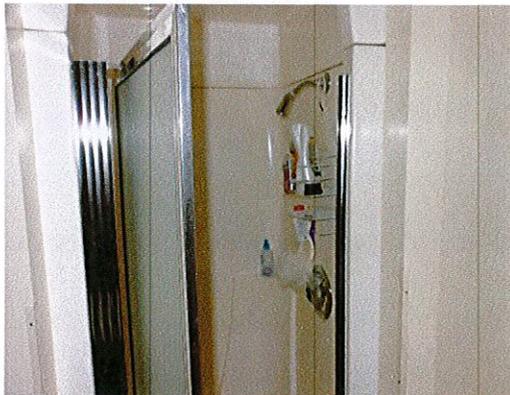
| Location JQP # / Item # | Solution / Comments | Qty | Unit Cost | Total Cost | Priority | Estimated Compl. Date | Person Responsible | Actual Compl. Date | Actual Cost |
|---|--|---|---|---|---|---|---|---|---|
| 24B1 15692 | Modify the size of the shower to be either a compliant roll-in shower (minimum 30" x 60") or a compliant transfer shower (36" x 36" exact). MN1341 608.2 <i>A small shower stall with no features of accessibility is currently provided. Photo 5.</i> | 1 | \$1,000 | \$1,000 | 4 | | | | |

Photo 5: View of shower. There are currently no features of accessibility provided.
