Park Maintenance - Parks Toolhouse

Accessibility Review

Park Maintenance - Park Toolhouse
Proposed Entry
City of Duluth, MN

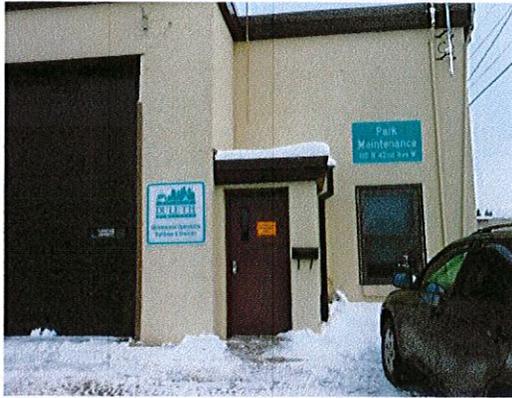
Photo 1: View of southwest entry. Replace the knob with a style that does not require grasping, pinching or twisting to operate (such as a lever).

| Location | Solution / Comments | | Qty | Unit Cost | Total Cost | Priority | Estimated Compl. Date | Person Responsible | Actual Compl. Date | Actual Cost |
|---|---|--|---|---|---|---|---|---|---|---|
| 12D 15626 | Provide door hardware that does not require grasping, pinching or twisting to operate, such as lever. Exterior security hardware. ICC / ANSI 404.2.6 <i>Photo 1.</i> | | 1 | \$325 | \$325 | 1 | | | | |

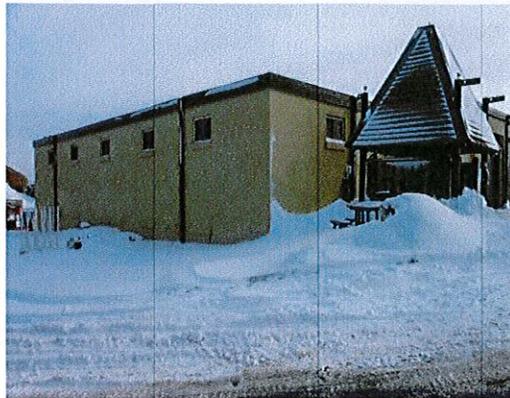
Photo 2: There is not currently an accessible route (interior or exterior) to the office / break room area of the building. (Approximately 36" rise.)

| Location JQP # / Item # | Solution / Comments | Qty | Unit Cost | Total Cost | Priority | Estimated Compl. Date | Person Responsible | Actual Compl. Date | Actual Cost |
|---|---|---|---|---|---|---|---|---|---|
| 14D3 15637 | Install a compliant lift to provide accessible between levels. IBC 1104.4 <i>There is not currently an accessible route to the office area of the building (includes offices, lockers, toilet rooms and break room). The rise is approximately 36" (measured at the exterior of the loading dock). Photo 2.</i> | 1 | \$20,000 | \$20,000 | 2 | | | | |

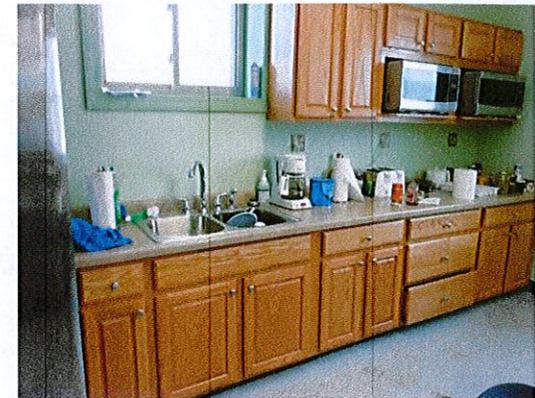
Photo 3: One side of the break room provides a kitchenette (no range provided) with sink and counter at 34". This is a good example of accessibility.

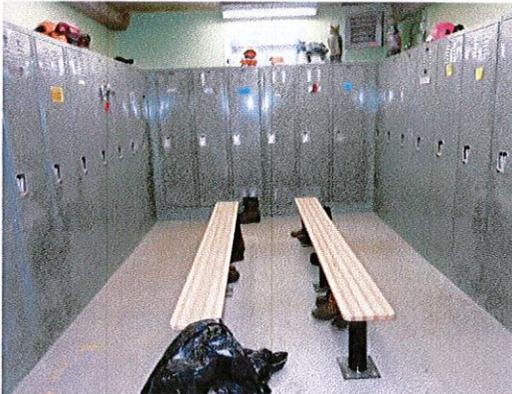
Photo 4: A new locker room area was created. Add an accessible bench (42" min x 20-24") with a back (or positioned against the wall).

| Location JQP # / Item # | Solution / Comments | Qty | Unit Cost | Total Cost | Priority | Estimated Compl. Date | Person Responsible | Actual Compl. Date | Actual Cost |
|---|--|---|---|---|---|---|---|---|---|
| 24V 15639 | In the changing/locker room, provide a bench, 20"-24" deep x 48" long, fixed to the wall or with a back along the longer dimension. The bench is to be mounted 17"-19" above the floor at the accessible dressing room and provide clear floor space at the end of the bench. MN1341 903 <i>Photo 4.</i> | 1 | \$200 | \$200 | 3 | | | | |

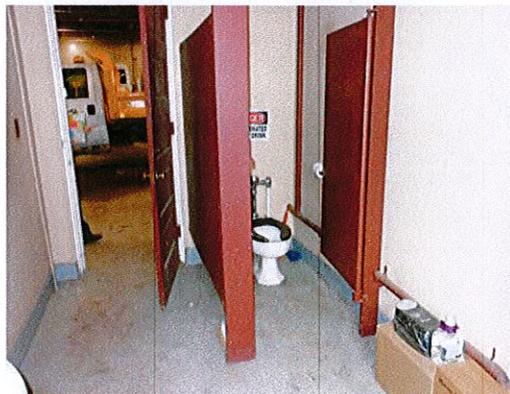
Photo 5: View of SW toilet room. Currently no features of accessibility have been provided. Direct to the new toilet rooms.

| Location JQP # / Item # | Solution / Comments | Qty | Unit Cost | Total Cost | Priority | Estimated Compl. Date | Person Responsible | Actual Compl. Date | Actual Cost |
|---|--|---|---|---|---|---|---|---|---|
| 22D 15632 | Remove interior partitions to create a single use toilet room. It is recommended that a privacy lock be installed. ICC / ANSI 603.2 <i>Photo 5.</i> | 1 | \$1,500 | \$1,500 | 4 | | | | |

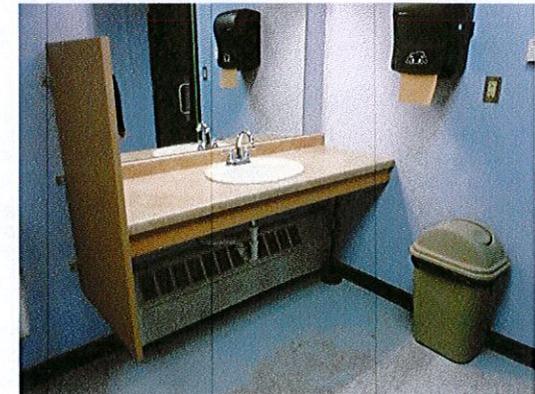
Photo 6: The rim of the sinks in the recently remodeled toilet rooms are currently at 34 1/2" vs. 34" (the counter is at 34").

| Location JQP # / Item # | Solution / Comments | Qty | Unit Cost | Total Cost | Priority | Estimated Compl. Date | Person Responsible | Actual Compl. Date | Actual Cost |
|---|---|---|---|---|---|---|---|---|---|
| 22P5 15646 | Lower lavatory so top edge is no higher than 34" AFF. ICC / ANSI 606.3 <i>Currently at 34 1/2" to the rim of the drop-in sink. Photo 6.</i> | 1 | \$500 | \$500 | 4 | | | | |

| Location JQP # / Item # | Solution / Comments | Qty | Unit Cost | Total Cost | Priority | Estimated Compl. Date | Person Responsible | Actual Compl. Date | Actual Cost |
|---|--|---|---|---|---|---|---|---|---|
| 22P5 15656 | Lower lavatory so top edge is no higher than 34" AFF. ICC / ANSI 606.3 <i>Currently at 34 1/2" to the rim of the drop-in sink. Photo 6.</i> | 1 | \$500 | \$500 | 4 | | | | |

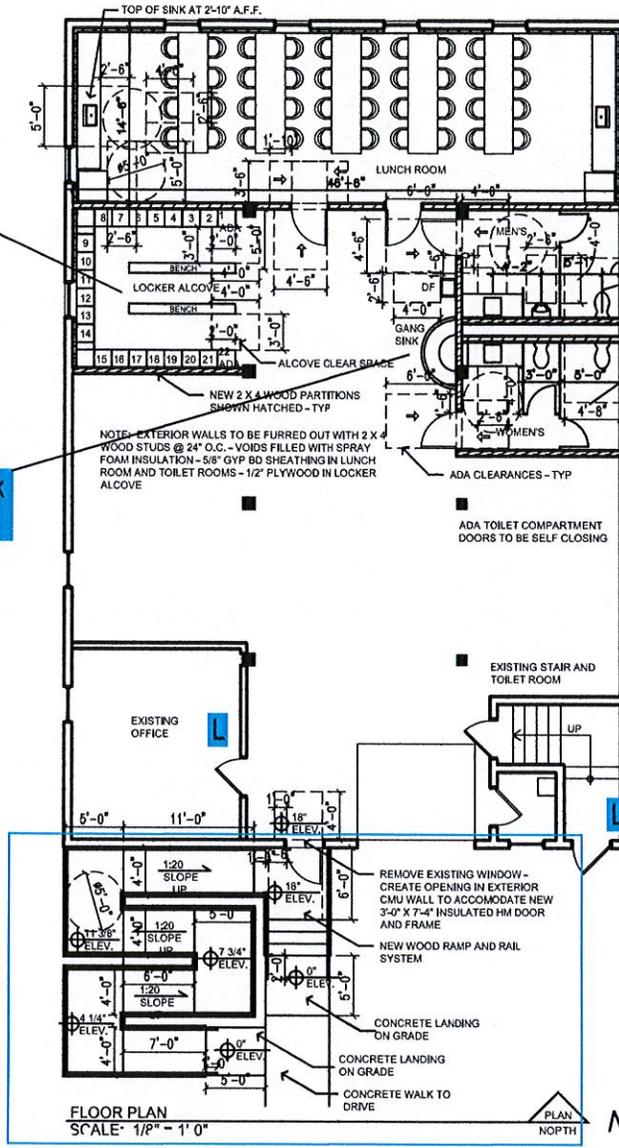
Provide an accessible bench

Provide accessible controls for sink
Lower the towel dispenser

Relocate the sign
Add staple style pulls to accessible stall door
Lower the coat hook
Insulate the pipes at the lavatory

Create an accessible route to the upper level
