# Lake Park Athletic Complex (Jean Duluth Soccer)

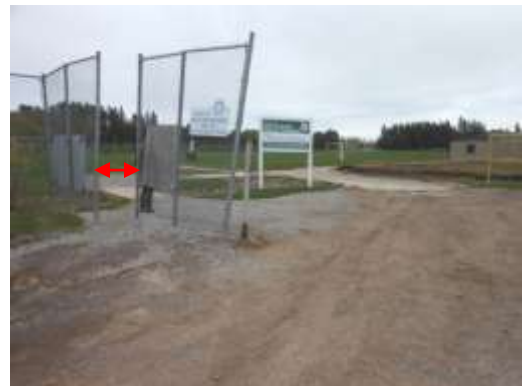
### Route- From North

There is a gravel pedestrian route from the north parking lot. The pedestrian gate currently provides a 29" clear opening. The adjacent vehicle gate is typically closed/locked.

**Priority 2-** Modify the width of the pedestrian gate to provide a 32" clear opening. *ADA 403.5.1*

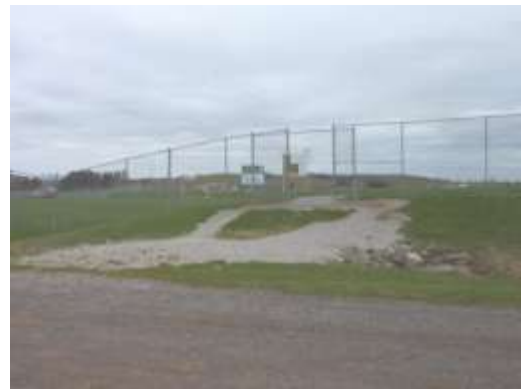
### Route- From South

There is a gravel route from the south parking lot to the fence opening into the soccer fields. The route is approximately 60' long and up a hill.

**Priority 2-** Post signs directing to the north parking lot for accessible parking and an accessible route.

**Priority 3-** Reconstruct to create an accessible route from the south parking lot. *ADA 206.2*

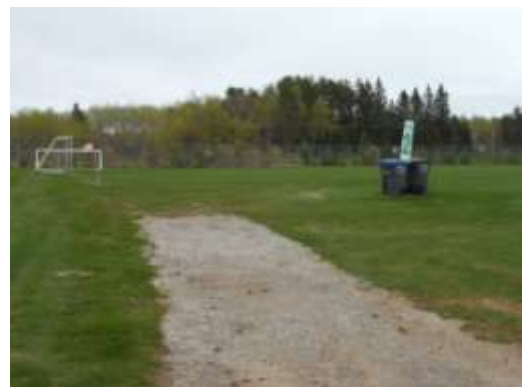
### Route- Fields 2 and 5

There is not currently an accessible route to the border of any of the soccer fields. Fields 2 and 5 would be the easiest to provide an accessible route to.

**Priority 2-** Create an accessible route to the boundary of soccer fields 2 and 5. *ADA 206.2.2*

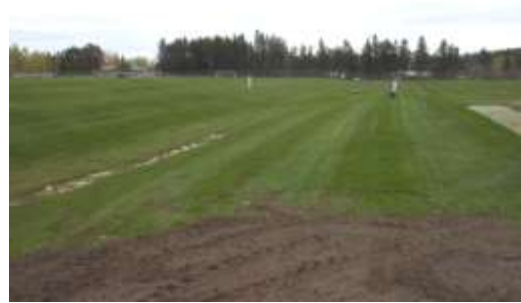
### **Route- Fields 1, 3 and 4**

There is not currently an accessible route to fields 1, 3 and 4. There are changes in elevation and significant distance to these 3 fields.

**Priority 1-** Relocate games scheduled on fields 1, 3 and 4 to an accessible location to accommodate participants and/or spectators as needed.

**Priority 3-** Create an accessible route to the boundary of the soccer fields. *ADA 206.2.2*

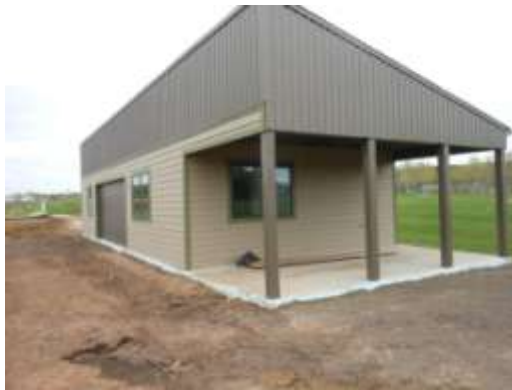
## **Storage Building- Soccer**

There is not currently an accessible route provided to the new building. It appears the building will be used for storage and office space (still under construction at the time of site visit).

**Priority 3-** Create an accessible route to the storage building. *ADA 206.2.2*

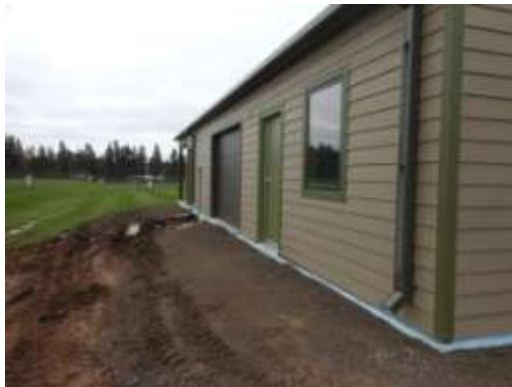
### **Entry**

The only pedestrian entry (there are 2 overhead garage doors) is on the east side of the building. There is currently a slope exceeding 2% at the entry.

**Priority 2-** Provide maneuvering clearance at the entry door with 2% maximum slope in any direction. *ADA 404.2.4, 404.2.4.4*

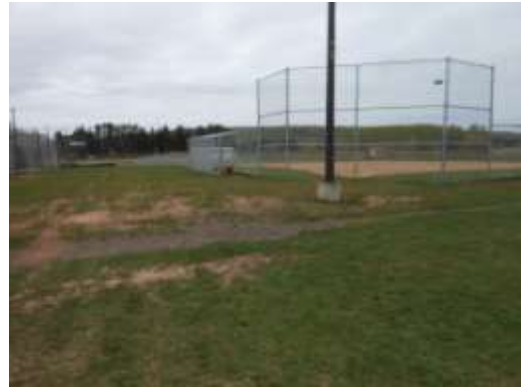
### Route

There is not currently an accessible route provided to any of the 6 ball fields. Some gravel has been added near the parking lot, but it does not extend to the fields and the size of gravel does not provide a firm and stable surface.

**Priority 2-** Create an accessible route to each of the fields, including player seating (dugouts) and spectator seating. *ADA 206.2.2, 221.2.1.4*

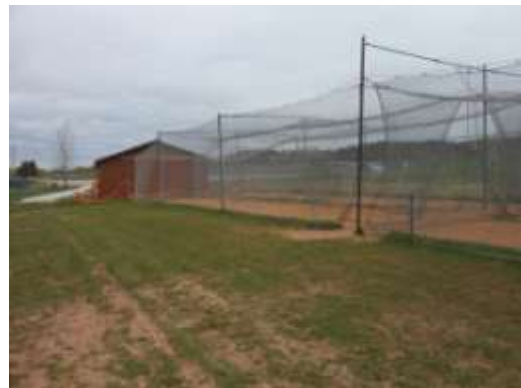
### Batting Cages

There are currently 4 batting cages available for use. An accessible route is not currently provided.

**Priority 3-** Create an accessible route to the entry to the batting cages. *ADA 206.2.2*

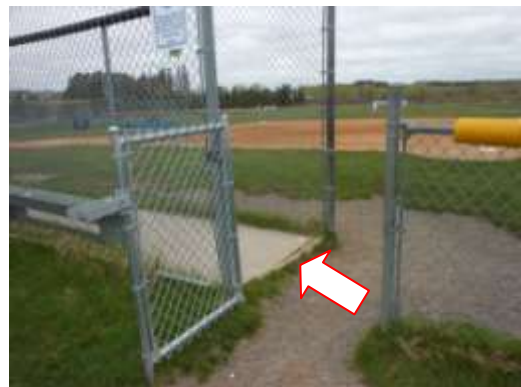
### Fields- A, B, C and D

An accessible route is provided from the gate into the field area and into the dugout. There is a change in elevation between the ground and the concrete pad of the dugout.

**Priority 3-** Patch/fill to eliminate the change in elevation into the dugouts. *ADA 303*

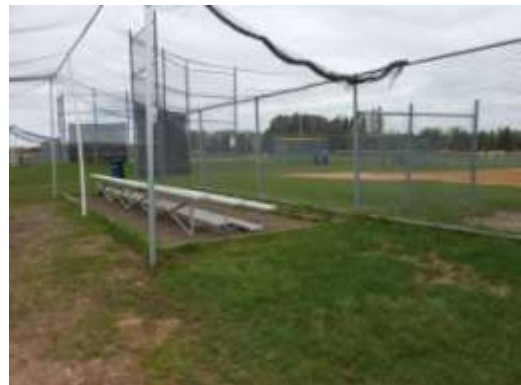
### Fields- A, B, C and D

Spectator seating has been provided at fields A, B, C and D. The movable bleachers are positioned in gravel, surrounded by a wood border.

**Priority 3-** Create a wheelchair space adjacent to the bleachers. *ADA 221.2*

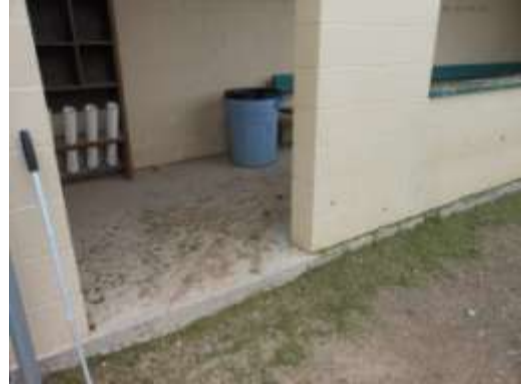
### Art Von Field

There is currently a 5" change in elevation between the ground and the concrete pad of the dugout on the 3rd base side.

**Priority 3-** Patch/fill to eliminate the change in elevation into the 3rd base side dugout. *ADA 303*

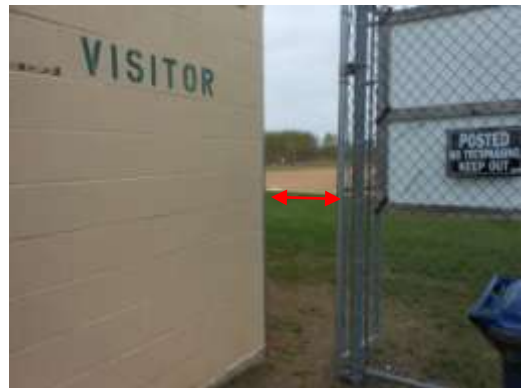
### Art Von Field

The gate opening onto the field and into the bleachers is currently 20 1/2" wide.

**Priority 2-** Modify the gate/fence to provide a 32" minimum clear opening. *ADA 404.2.3*

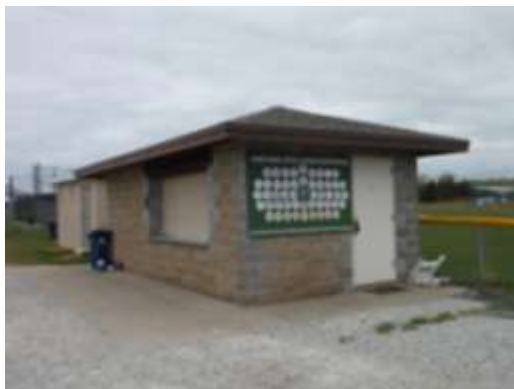
## Concession Building- Baseball

There is currently a 4" rise at the entry to the concession building and the door has knob style hardware.

**Priority 3-** Modify the entry to eliminate the 4" rise. *ADA 404.2.5*

**Priority 3-** Replace the knob style hardware with a style that does not require grasping, pinching or twisting of the wrist to operate (such as a lever). *ADA 309.4*

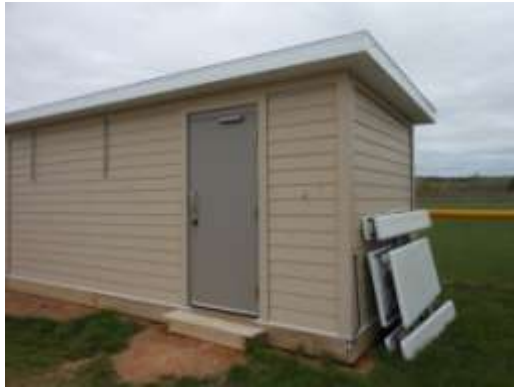
## Storage Buildings- Baseball

There are 3 storage buildings serving the baseball fields. An accessible route is not currently provided to the storage buildings. The newest storage building (adjacent to the concession stand) currently has 2 steps up to the entry.

***Priority 3-*** Create an accessible route to the storage buildings. *ADA 206.2.2*

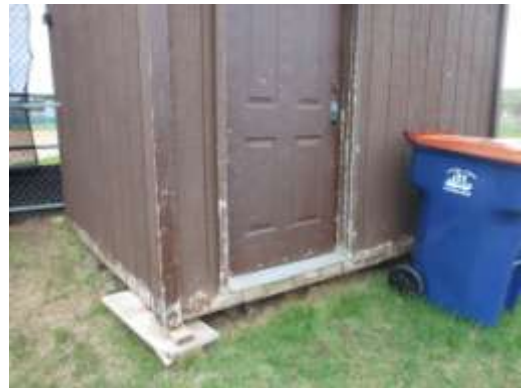
## Score Keepers Booth

There is a score keepers booth at Field D. There is a 12" rise into the booth.

***Priority 3-*** Create an accessible route into the score keepers booth. *ADA 206.2.2*

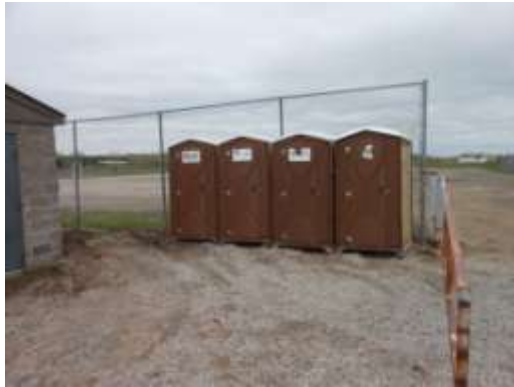
### Portable Toilets- Soccer

There are currently 4 portable toilets located in the gravel near the north entry to the soccer fields. Currently none of the portable toilets is a larger/accessible style and there is not an accessible route.

**Priority 2-** Provide a minimum of 1 larger/accessible style portable toilet at an accessible location. *ADA 206.2.2, 213.2 Exception 3*

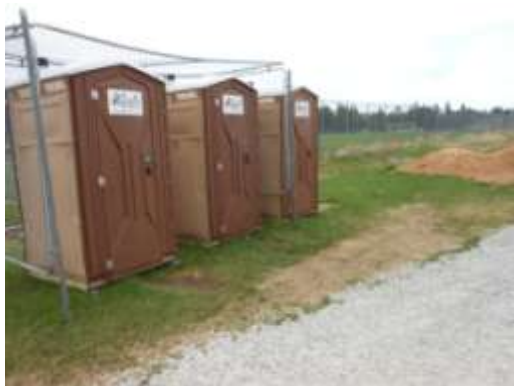
### Portable Toilets- Baseball

There are currently 3 portable toilets located in the grass near the entry to the baseball fields. Currently none of the portable toilets is a larger/accessible style and there is not an accessible route.

**Priority 2-** Provide a minimum of 1 larger/accessible style portable toilet at an accessible location. *ADA 206.2.2, 213.2 Exception 3*

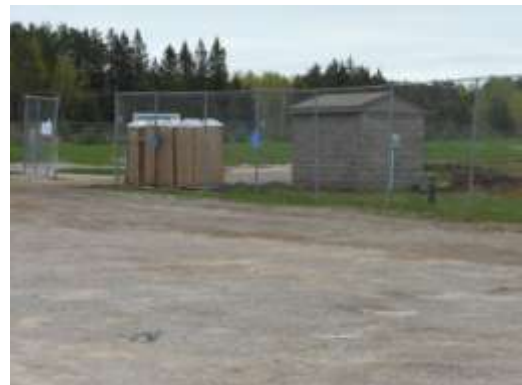
### Size- North

There is room for approximately 150 vehicles in the gravel parking lot at the north end of the park. There are 2 signs near the soccer entry designating accessible parking spaces. Based on the total number of parking spaces, a minimum of 5 accessible parking spaces are required.

The designated accessible spaces are not currently striped (or marked on the gravel surface).

**Priority 2-** Designate 3 additional accessible parking space. *ADA 208.2*

**Priority 2-** Stripe the accessible parking spaces to provide an 8' wide minimum space with an 8' wide minimum aisle. (Note: 2 spaces can share an aisle.)  
*MN1341 502.4.2*

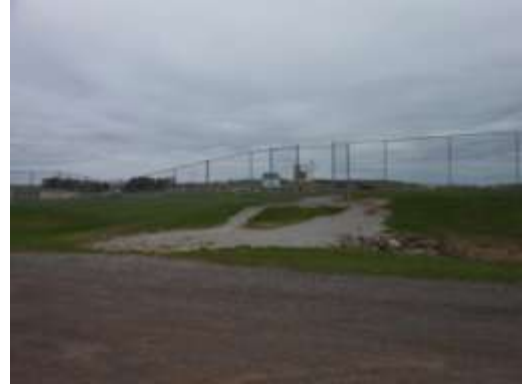
**Quantity- South**

There south parking lot has room for approximately 80 vehicles. Currently no spaces have been designated as accessible. An accessible route is not currently provided from this parking lot to the soccer or baseball fields.

**Priority 3-** Designate 4 accessible parking spaces. JQP, Inc. recommends locating these 4 signs in the north lot, and posting a sign in the south lot indicating their location. ADA 208.2
