Chester Park- Upper

Activities / Amenities

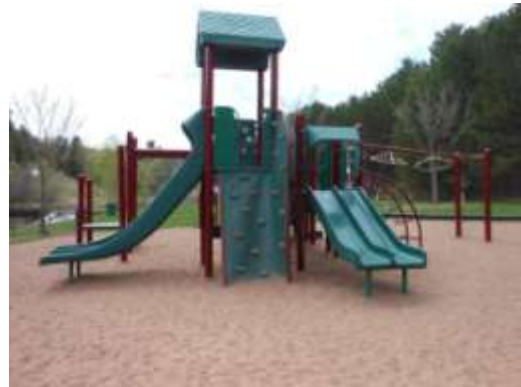
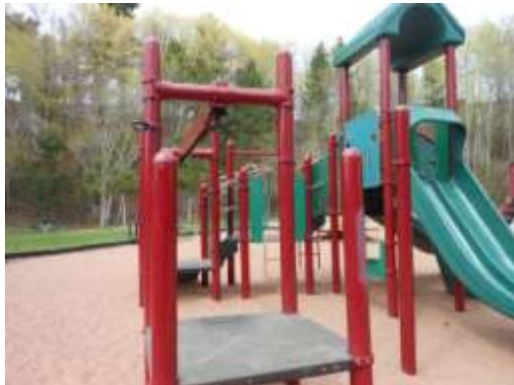
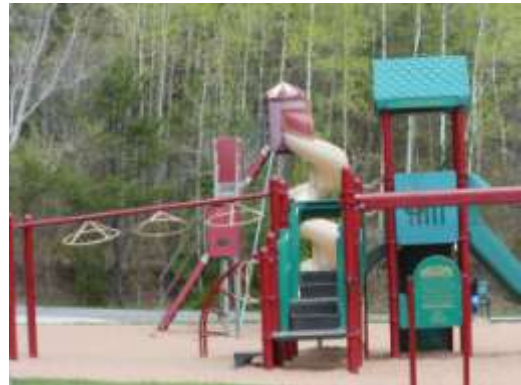
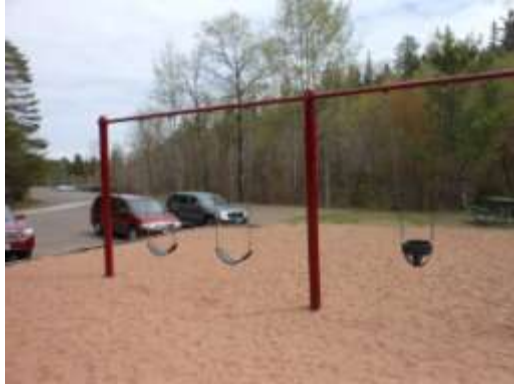
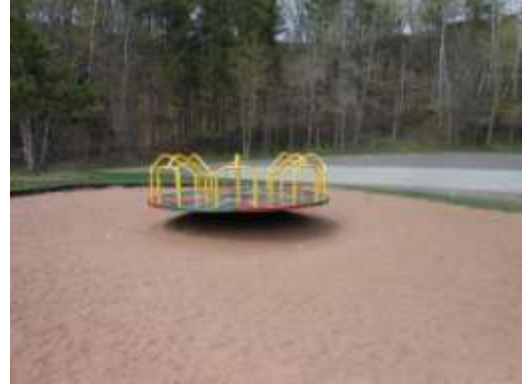
Defined Play Area

The defined play area includes 1 composite play structure, to-fro swings (2 strap style, 2 bucket style), merry-go round and free-standing slide. An adequate quantity of ground level components have been provided. *This is a good example of accessibility.*

Loose fill sand is used throughout the defined play area.

Priority 2- Replace the loose fill sand with a surface material with a type that complies with ASTM 1292 for impact attenuation and ASTM 1951 for accessibility. *ADA 206.2.17*

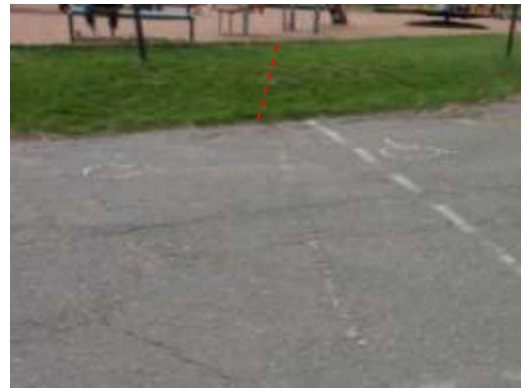
Defined Play Area- Route

There is not currently an accessible route to the defined play area.

Priority 1- Create an accessible route to the defined play area. ADA 206.2.2

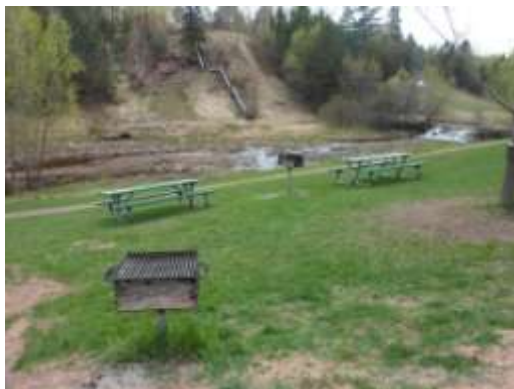
Picnic Tables and Grills- River

There are 13 tables and 2 grill provided in the grass near the river, currently none of the tables provides a position with knee and toe clearance and there is not an accessible route.

Priority 2- Create an accessible route to the picnic area.

Priority 3- Provide a picnic table that provides knee and toe clearance. *Recommended based on Draft Accessibility Guidelines for Outdoor Developed Areas 1011.4*

Priority 3- Add an accessible route to the grill, add a grill at an accessible location or relocate the grill to an accessible location. *Recommended based on Draft Accessibility Guidelines for Outdoor Developed Areas 1011.1*

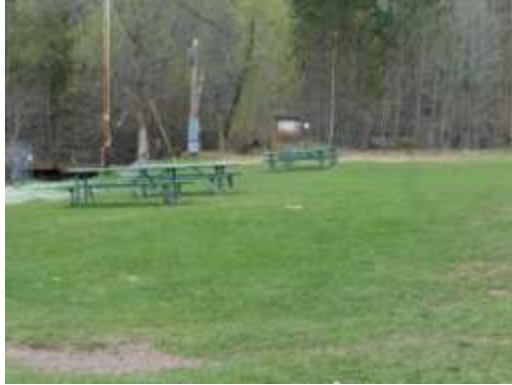
Picnic Tables- Northwest

There are 6 tables in the grass near the open field at the northwest end of the park. Currently none of the tables provides a position with knee and toe clearance and there is not an accessible route.

Priority 2- Create an accessible route to the picnic area.

Priority 3- Provide a picnic table that provides knee and toe clearance. *Recommended based on Draft Accessibility Guidelines for Outdoor Developed Areas 1011.4*

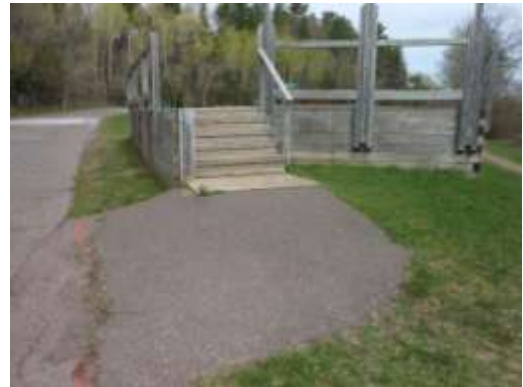
Stage

There is a stage positioned at the bottom of the ski hill, near the play area. There is currently a 44" rise to the stage; an accessible route is not provided.

Priority 2- Add a ramp to create an accessible route on to the stage. *ADA 206.2.6*

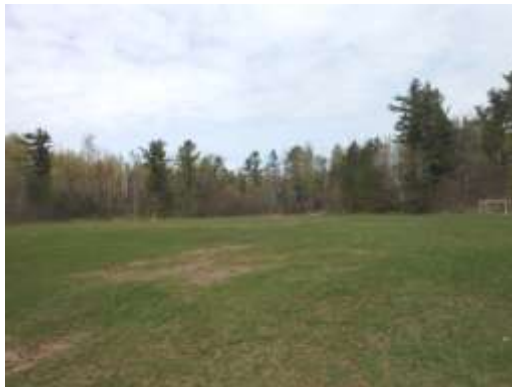
Play Field

There is an open play field (not striped at time of site visit) with lights. An accessible route is not currently provided to the field.

Priority 3- Create an accessible route to the field. *ADA 206.2.2*

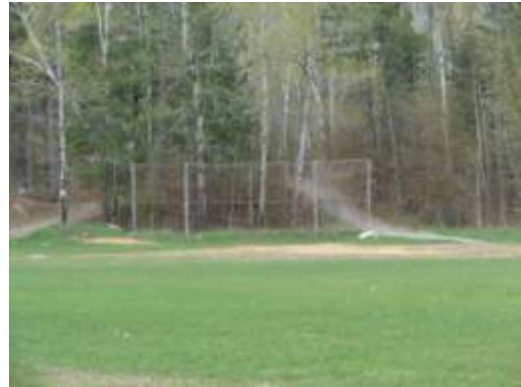
Baseball Field

There is a baseball field in the northeast corner of the park. It appears that the baseball field is currently abandoned. An accessible route has not been provided.

Priority 3- If the baseball field is used, create an accessible route to it. *ADA 206.2.2*

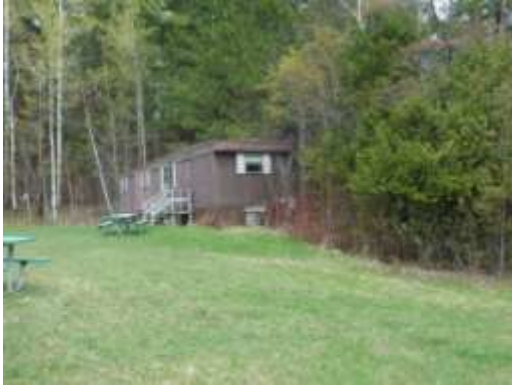
Trailer

There is a trailer building near the open field. It is unclear if the trailer is currently used and what it is/was used for (office, warming house, storage, residence, etc.). An accessible route has not been provided and there are 5 steps to the entry door.

Priority 3- If the trailer is used for park and recreation programs, create an accessible route up to and into the trailer. *ADA 206.2.2*

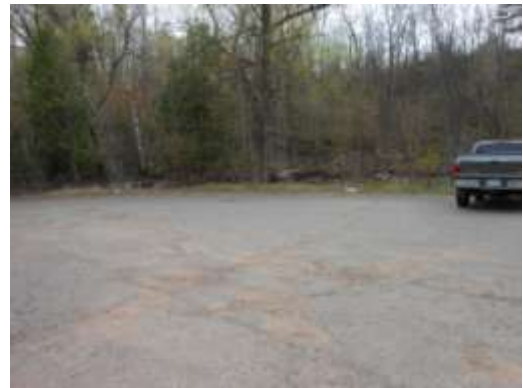
Parking- Northwest

There is a parking lot in the northwest corner of the park with room for approximately 35 vehicles. The lot is not currently striped and no spaces have been designated as accessible.

Priority 2- Designate 2 accessible parking space. *ADA 208.2*

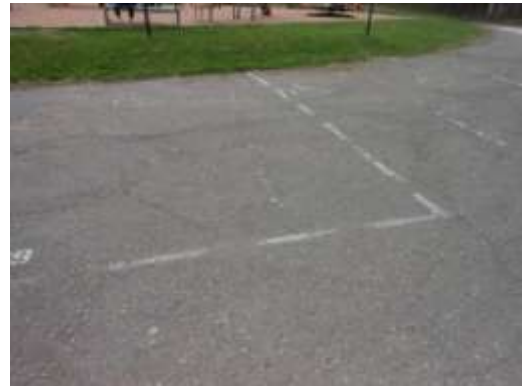
Parking- Play

There are marked parking spaces along the road, near the play area. There are approximately 80 parking spaces, including 4 that have been designated as accessible. The accessible parking spaces have the International Symbol of Accessibility painted on the surface and there are 2 signs. Note: the striping is currently faded.

Priority 2- Restripe the accessible parking spaces to provide an 8' wide minimum space with an 8' wide minimum aisle. (Note: 2 spaces can share an aisle.) *MN1341 502.4.2*

Priority 3- Provide a sign centered at the head end of each of the parking spaces. *MN1341 502.7*
